Manhole Inspection Summary

Manhole # S29EE1011MH

Location Address: **3910 KESWICK RD**

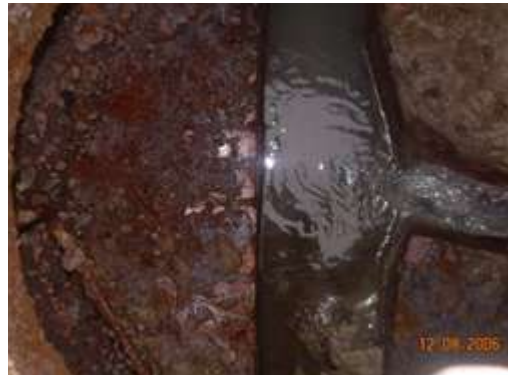
Top View

Corroded steps. Channel and Bench debris.

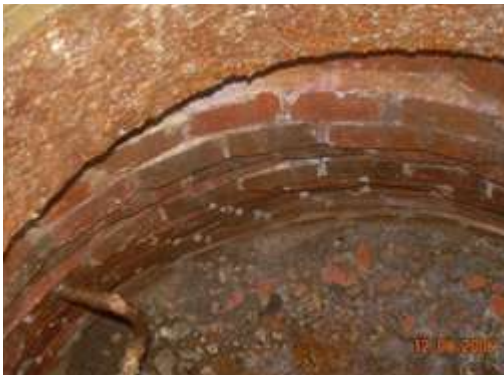
Defect

Frame leaks. Frame offset. Adjustment infiltration.

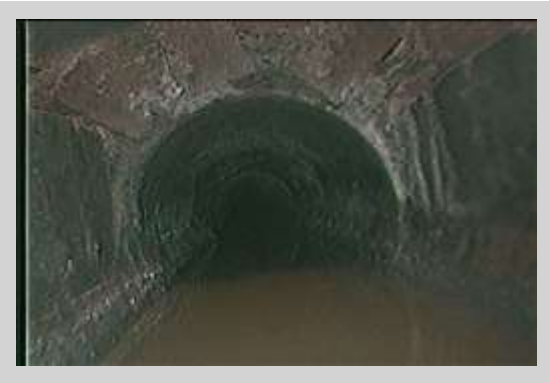
8 in. Circular Gravity Sewer Pipe Out @ 12 O'Clock

Infiltration: **Evidence** Pipe Seal Cond: **Unknown**

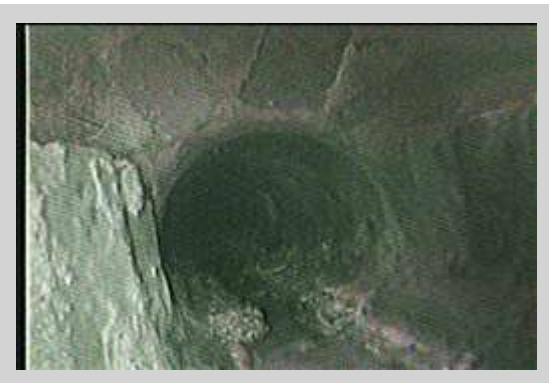
6 in. Circular Gravity Sewer Pipe In @ 3 O'Clock

Deposits: ☐ None ☐ Mud ☐ Sludge ☐ Debris ☒ Grease

Silt Depth: **0.5** (in.) Deposits Extent: **Light**

Infiltration: **Evidence** Pipe Seal Cond: **Unknown**

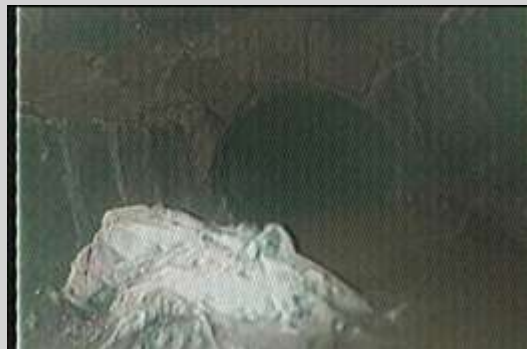
8 in. Circular Gravity Sewer

Infiltration: **Evidence**

Pipe Seal Cond: **Cracked**
